Challenger Seven Memorial Park Habitat Restoration Project **Final Report**

By Grant Moss, Eric Rukstuhl, and Brittani Flowers
Bayou Preservation Association
Submitted to HCP1 May 2022

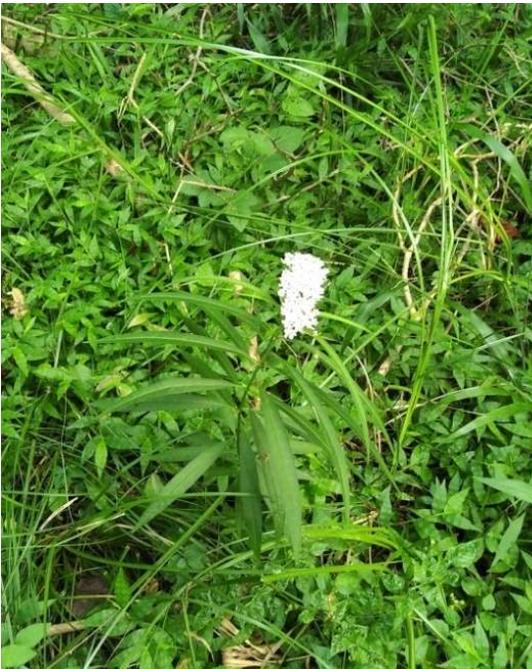
**Aquatic Milkweed
(*Asclepia perennis*)
appearing after
invasive clearing**

The Challenger Seven riparian restoration project resulted in the improvement of 48.9 acres of habitat, as well as the planting of 35 native wetland plants. We have already begun to see the re-emergence of native species by natural recruitment and are optimistic about the return of native biodiversity with continued maintenance of the site. Native plants that we have observed re-emerging during this project include: Aquatic Milkweed (*Asclepia perennis*), Ironweed (*Vernonia sp.*), Yellow Passionflower (*Passiflora lutea*), and Downy Lobelia (*Lobelia puberula*)

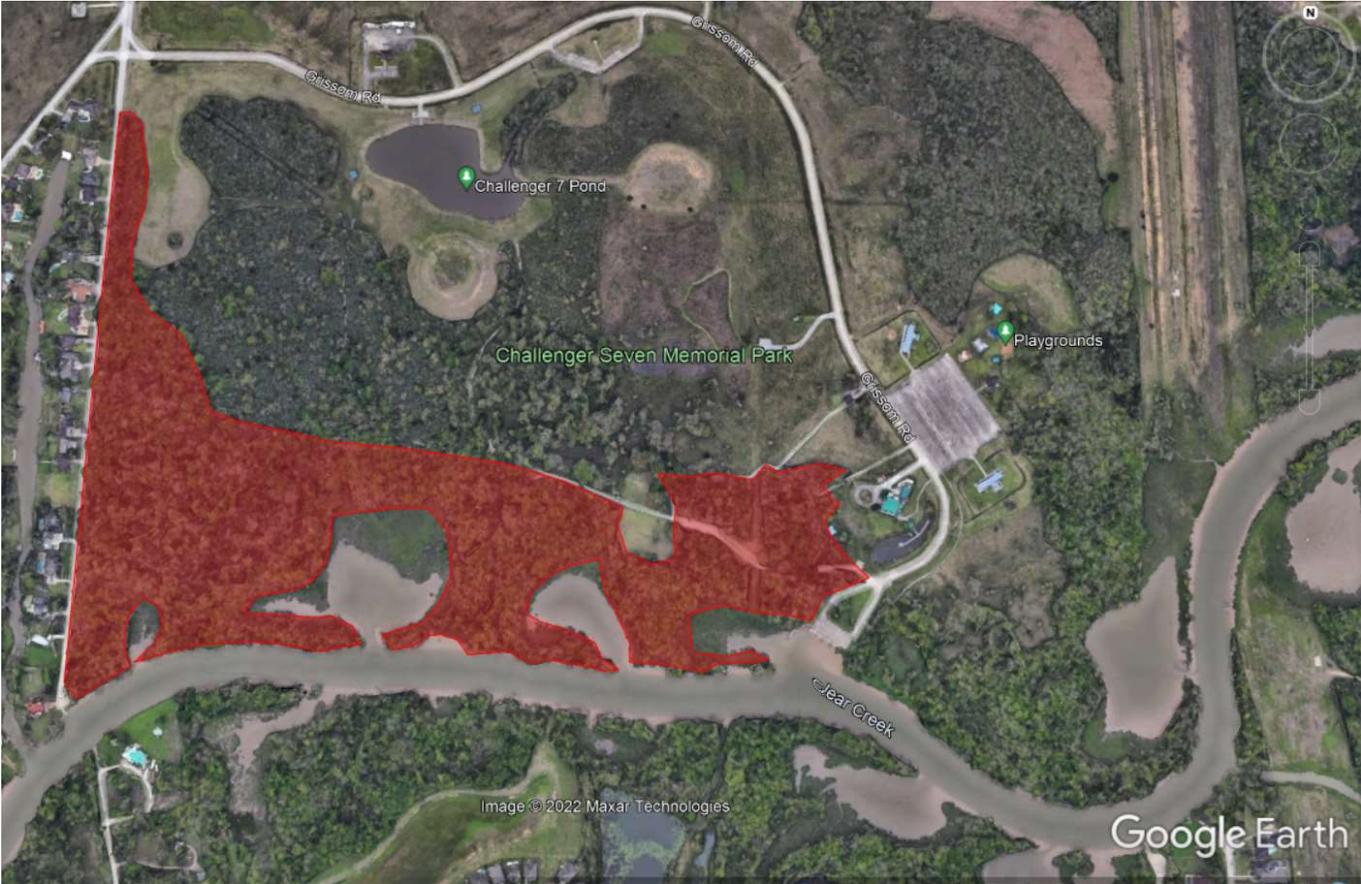
Figure 1. Map of Challenger Seven Habitat Restoration Work Site

Bayou Preservation also hired Student Conservation Association and Texas Conservation Corps work crews to assist EBR in removal and treatment of invasives. Together, our work crews were able to improve 48.9 acres (Appendix 1) of riparian habitat.

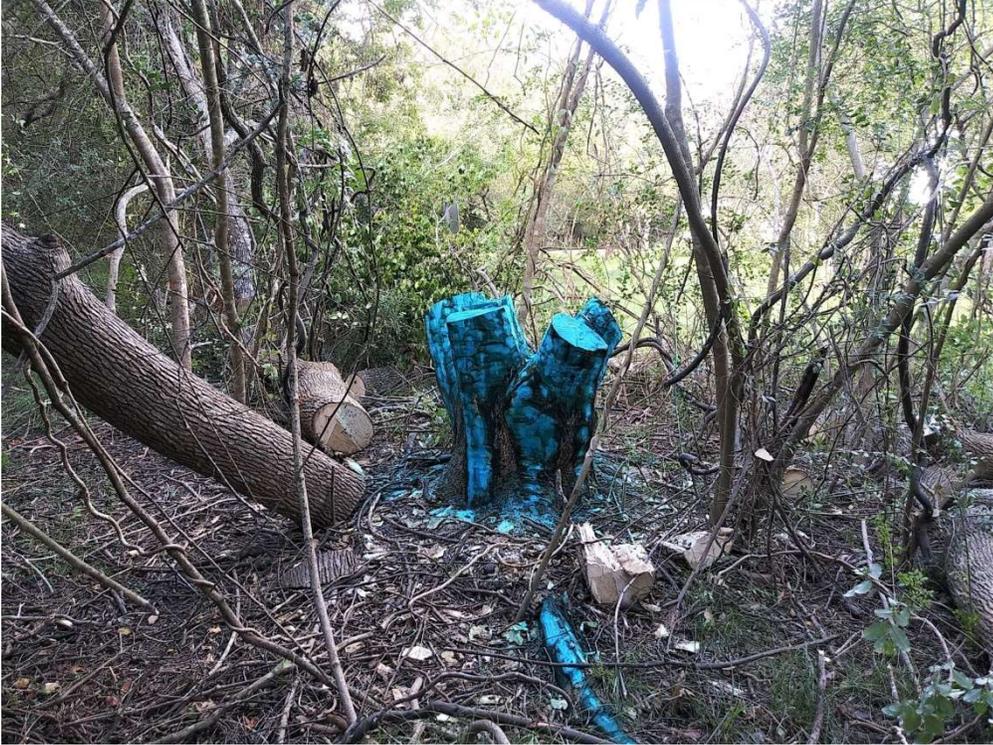
Figure 2. Treated large, multi-trunked Chinese Tallow Tree

Removals were done through the use of hand tools such as chainsaws, hand saws, pole saws, and loppers. Cut plants were then followed up with herbicide treatment with appropriate, water-safe herbicides.

- ▶ Invasive plants were marked with paint by experienced practitioners to make identification of plants easy for those less experienced in plant identification
- ▶ Marked plants were then cut, making sure that some of the stump, as well as the paint markings, were still visible for those following up with herbicide treatment
- ▶ Leaf litter and cut debris were then removed from the base of the plant and the plant was cut to expose as much of the cambium layer as possible
- ▶ Herbicide was then sprayed carefully and directly onto the freshly exposed cambium layer
- ▶ Mop-ups of previously treated areas were performed regularly to check for missed plants, plants that were not fully killed, and newly emerging seedlings

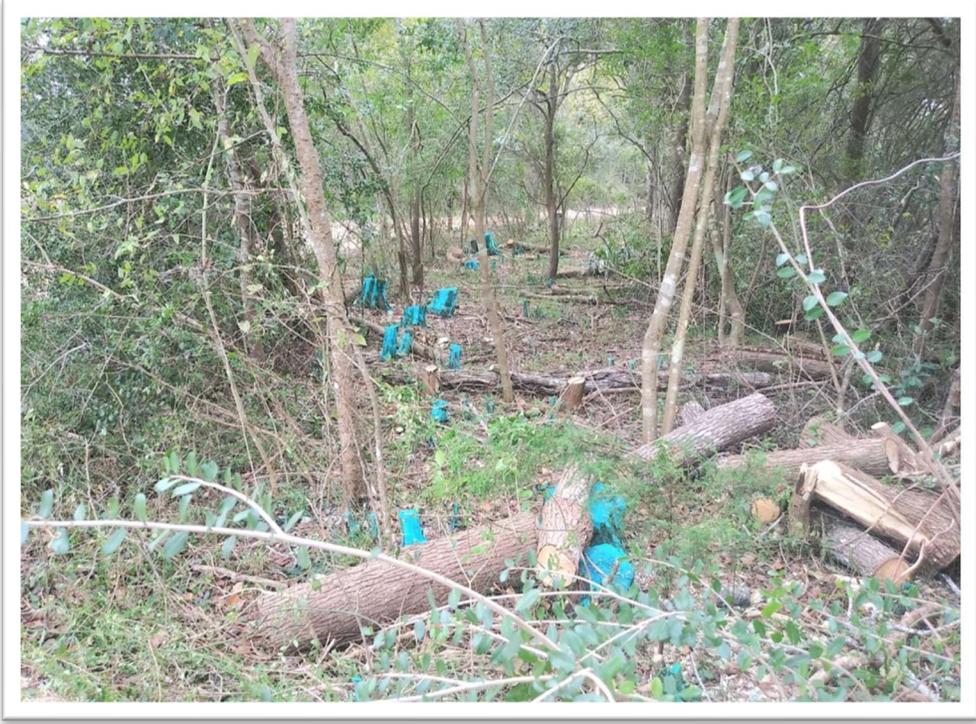
Figure 3. Large number of treated stumps

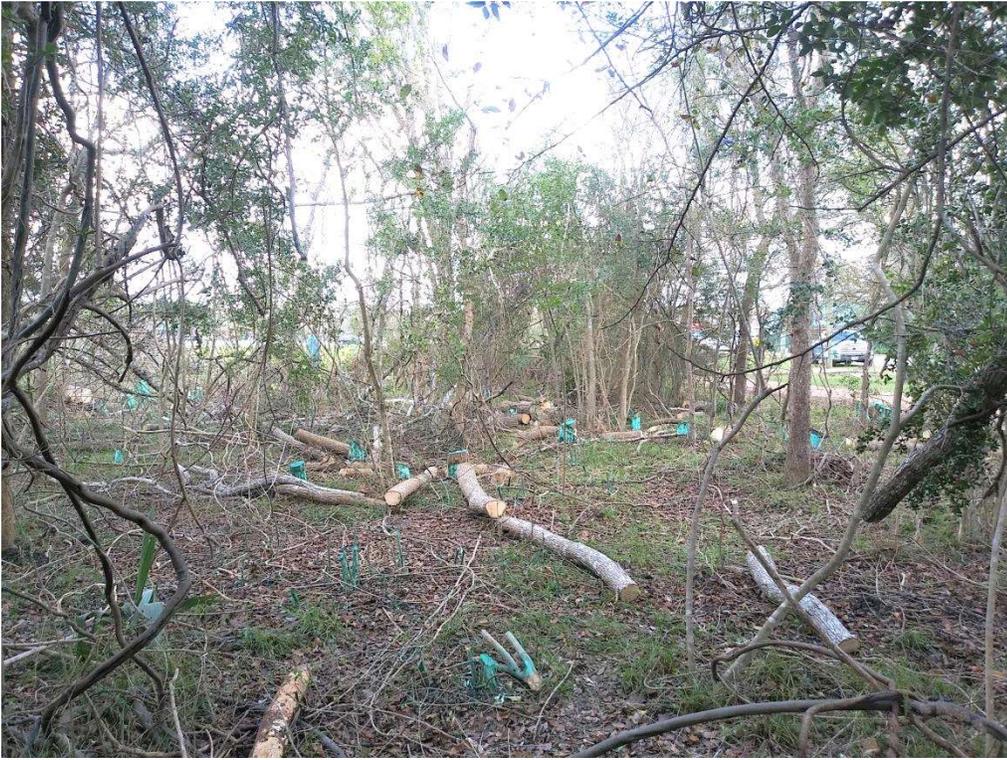
Figure 4. Large felled Ligustrum trees and treated stumps

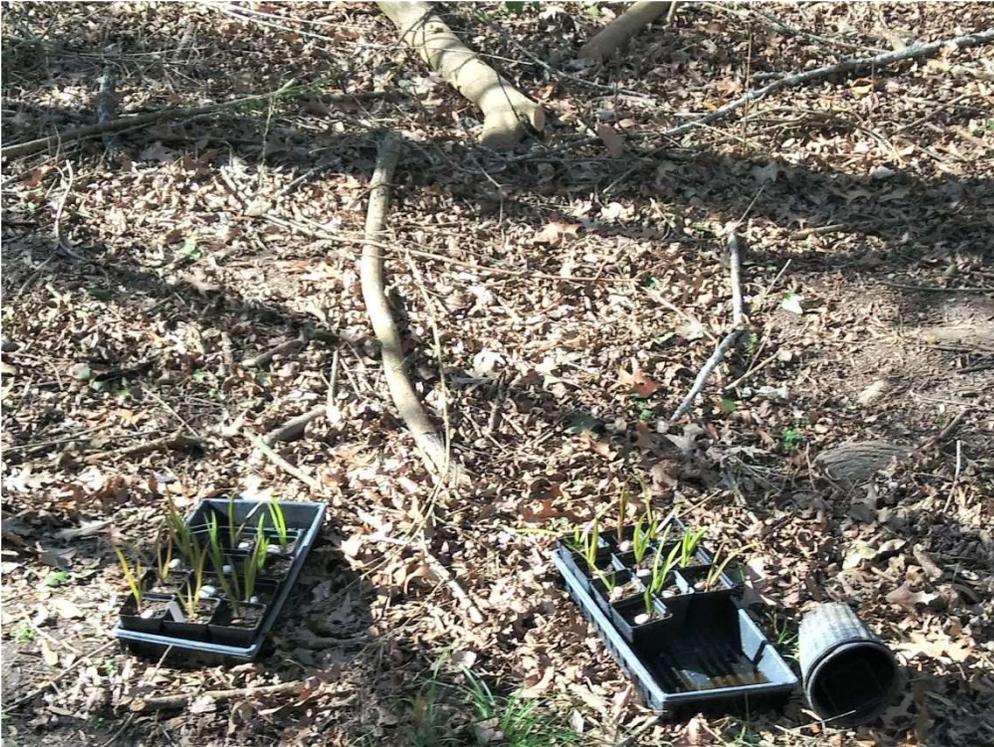
Figure 6. Native wetland plants planted in a restored tributary of Clear Creek

A small supplemental planting of 35 native wetland plants was conducted on March 02, 2022 in a visible drainage cleared of invasives. We hoped to improve species diversity and water quality while also improving aesthetics by choosing species with showy blooms. Species planted include: 30 American Crinum Lily (*Crinum americanum*), 3 Blue Flag Iris (*Iris virginica*), and 2 Purple Pickerel Weed (*Pontederia cordata*).

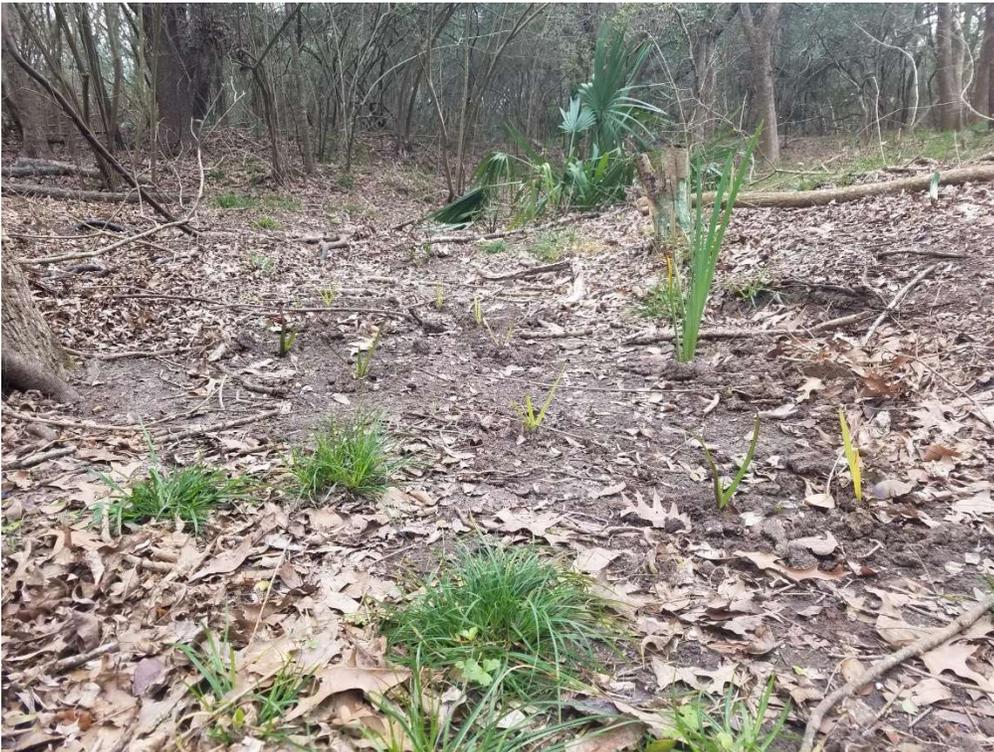
Figure 7. Native wetland plants after planting
